United States
Circuit Court of Appeals
For the Ninth Circuit.

UNITED STATES OF AMERICA,
Appellant,

J. LESLIE MORRIS COMPANY, INC., a cor-
poration,
Appellee.

Transcript of Record
(Plaintiff's Exhibits 1 to 32)

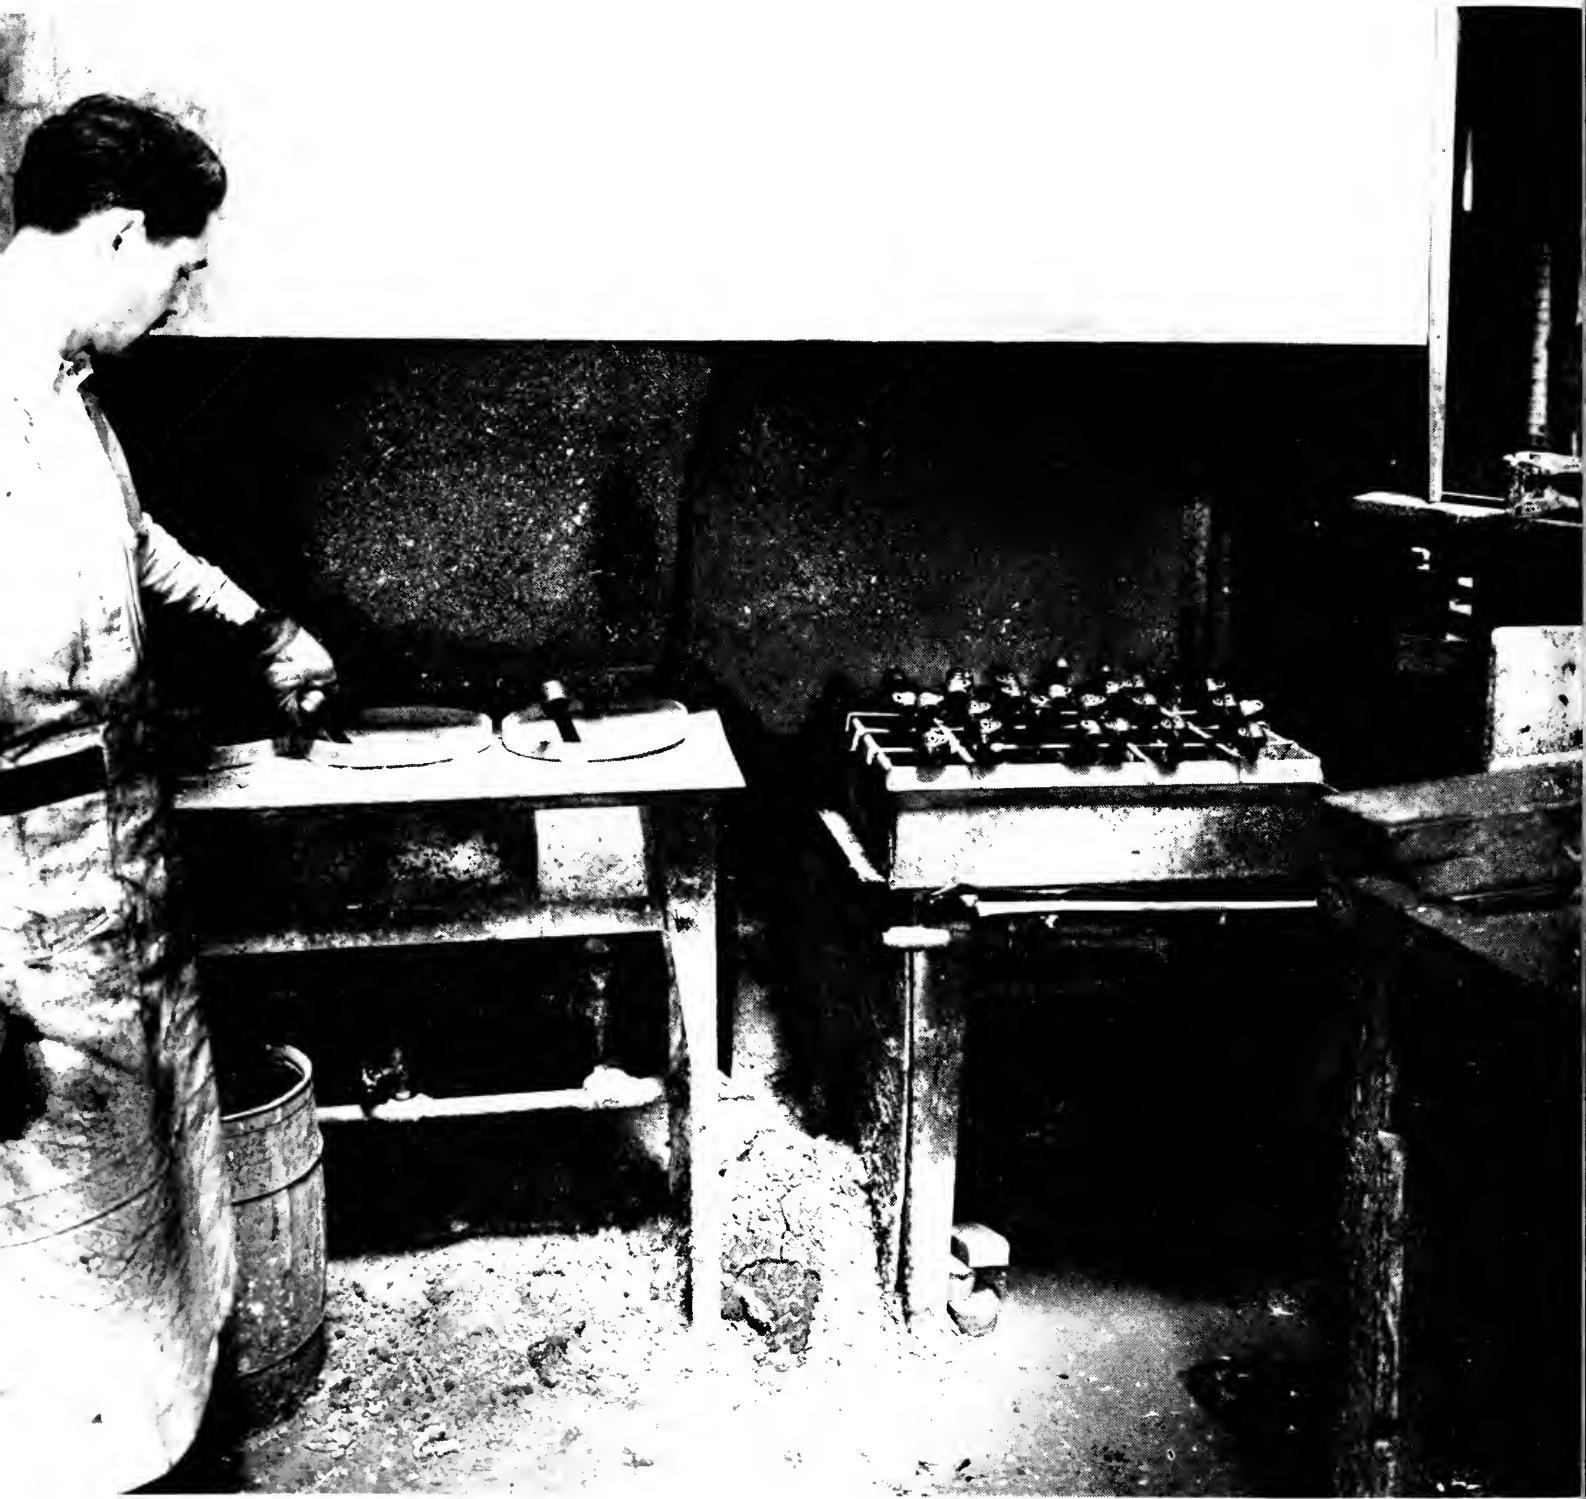
PLAINTIFF'S EXHIBIT No. 6

Then the babbitt is melted from the bearing end of the rod by placing that end into a low temperature pot of molten babbitt which the night man prepares by lighting the oven at approximately five o'clock in the morning in preparation for the days run. It is heated with an ordinary gas stove burner. This operation is illustrated in the right half of the above picture. After most of the babbitt is removed by this method, the remainder of the adhering babbitt or dross which sometimes clings to the rods is removed by dipping them into the dross pots shown to the left in the above picture. The dross pots keep a solution of molten babbitt at a higher temperature. In order to keep the babbitt at a sufficiently high temperature three approximately one half gallon pots are used. The reason for the babbitt being removed by two operations is that the babbitt in the low temperature receptacle may be used by Plaintiff corporation for rebabbitting, while the higher temperatures in the dross pots spoil the babbitt for such use.

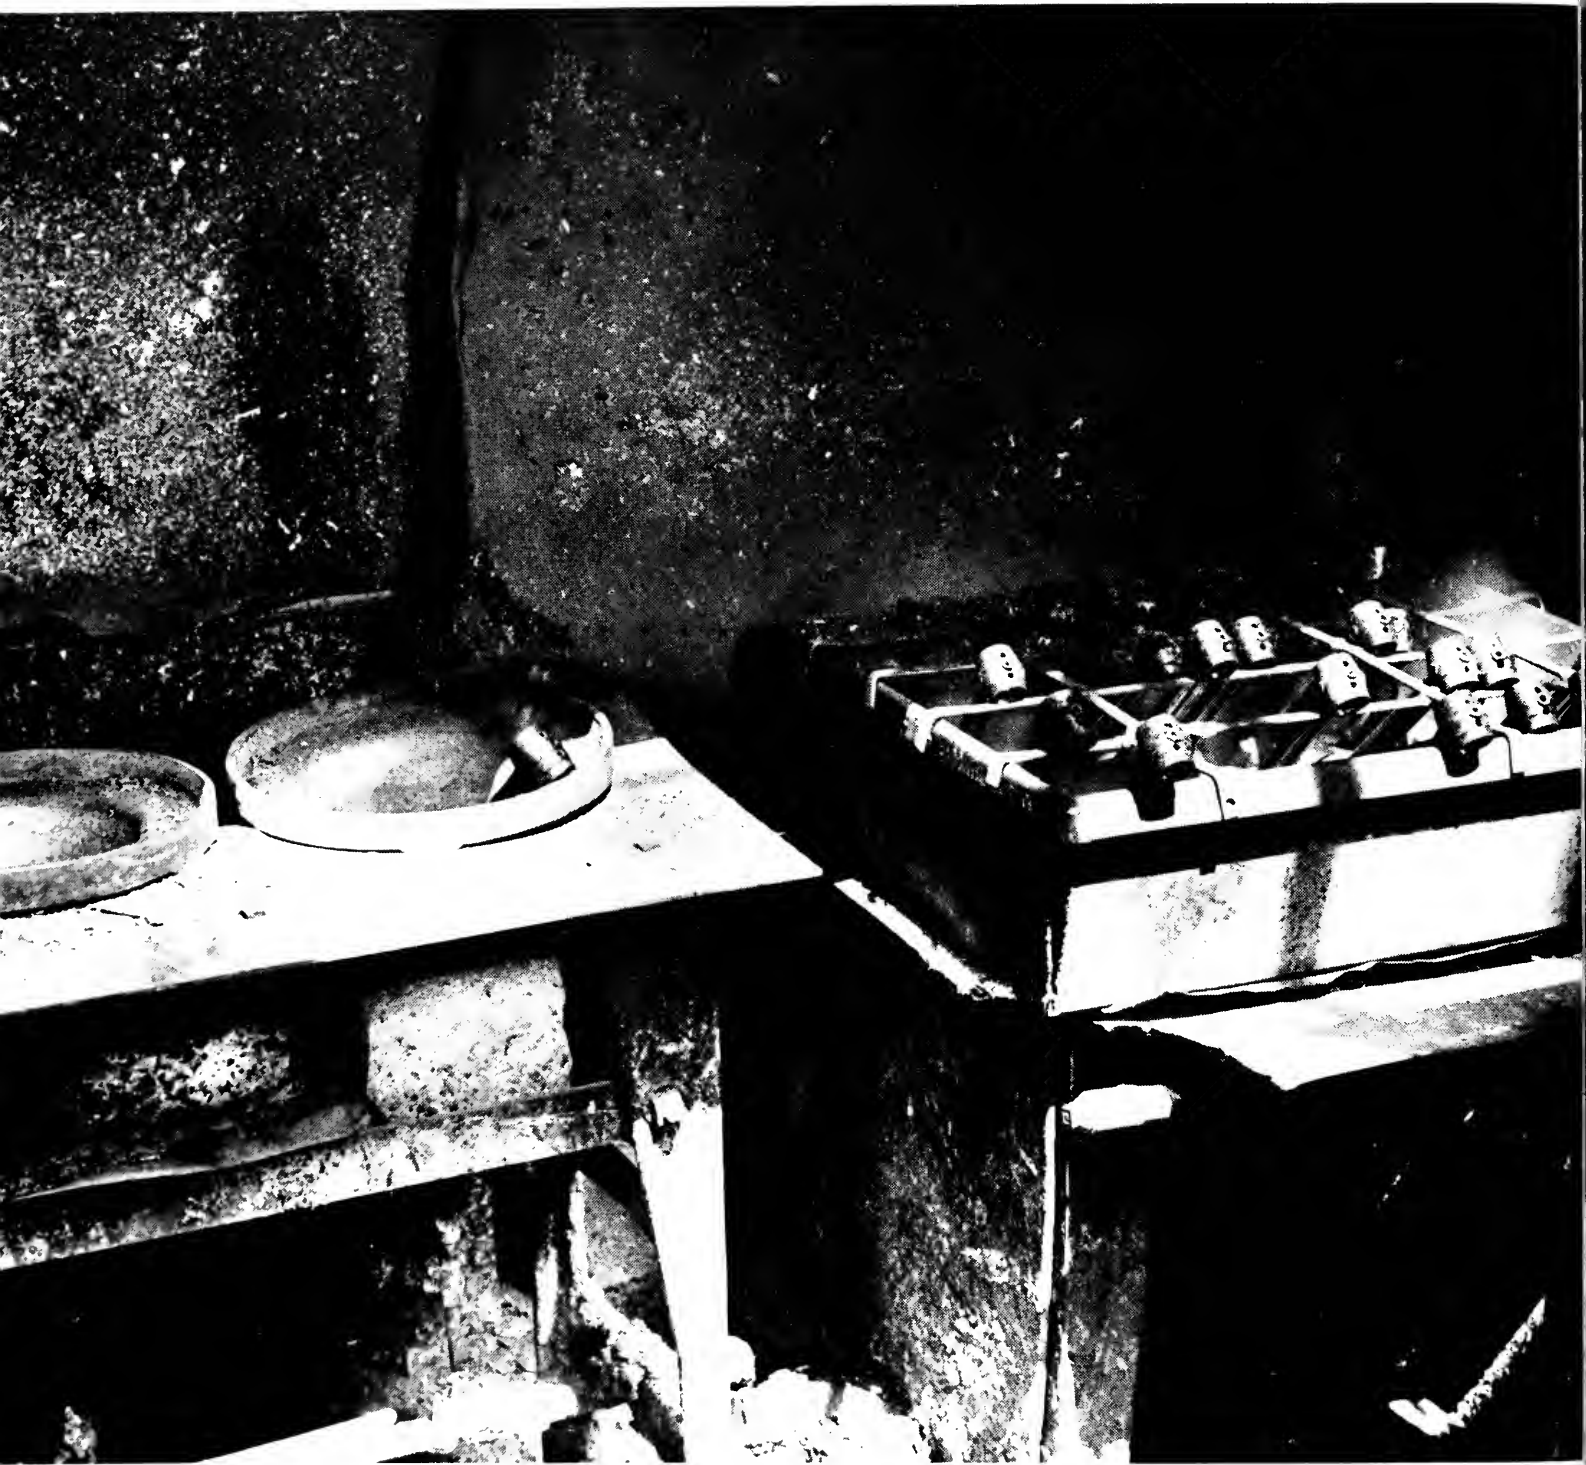
PLAINTIFF'S EXHIBIT No. 7

Close-up of operation illustrated in picture 6.

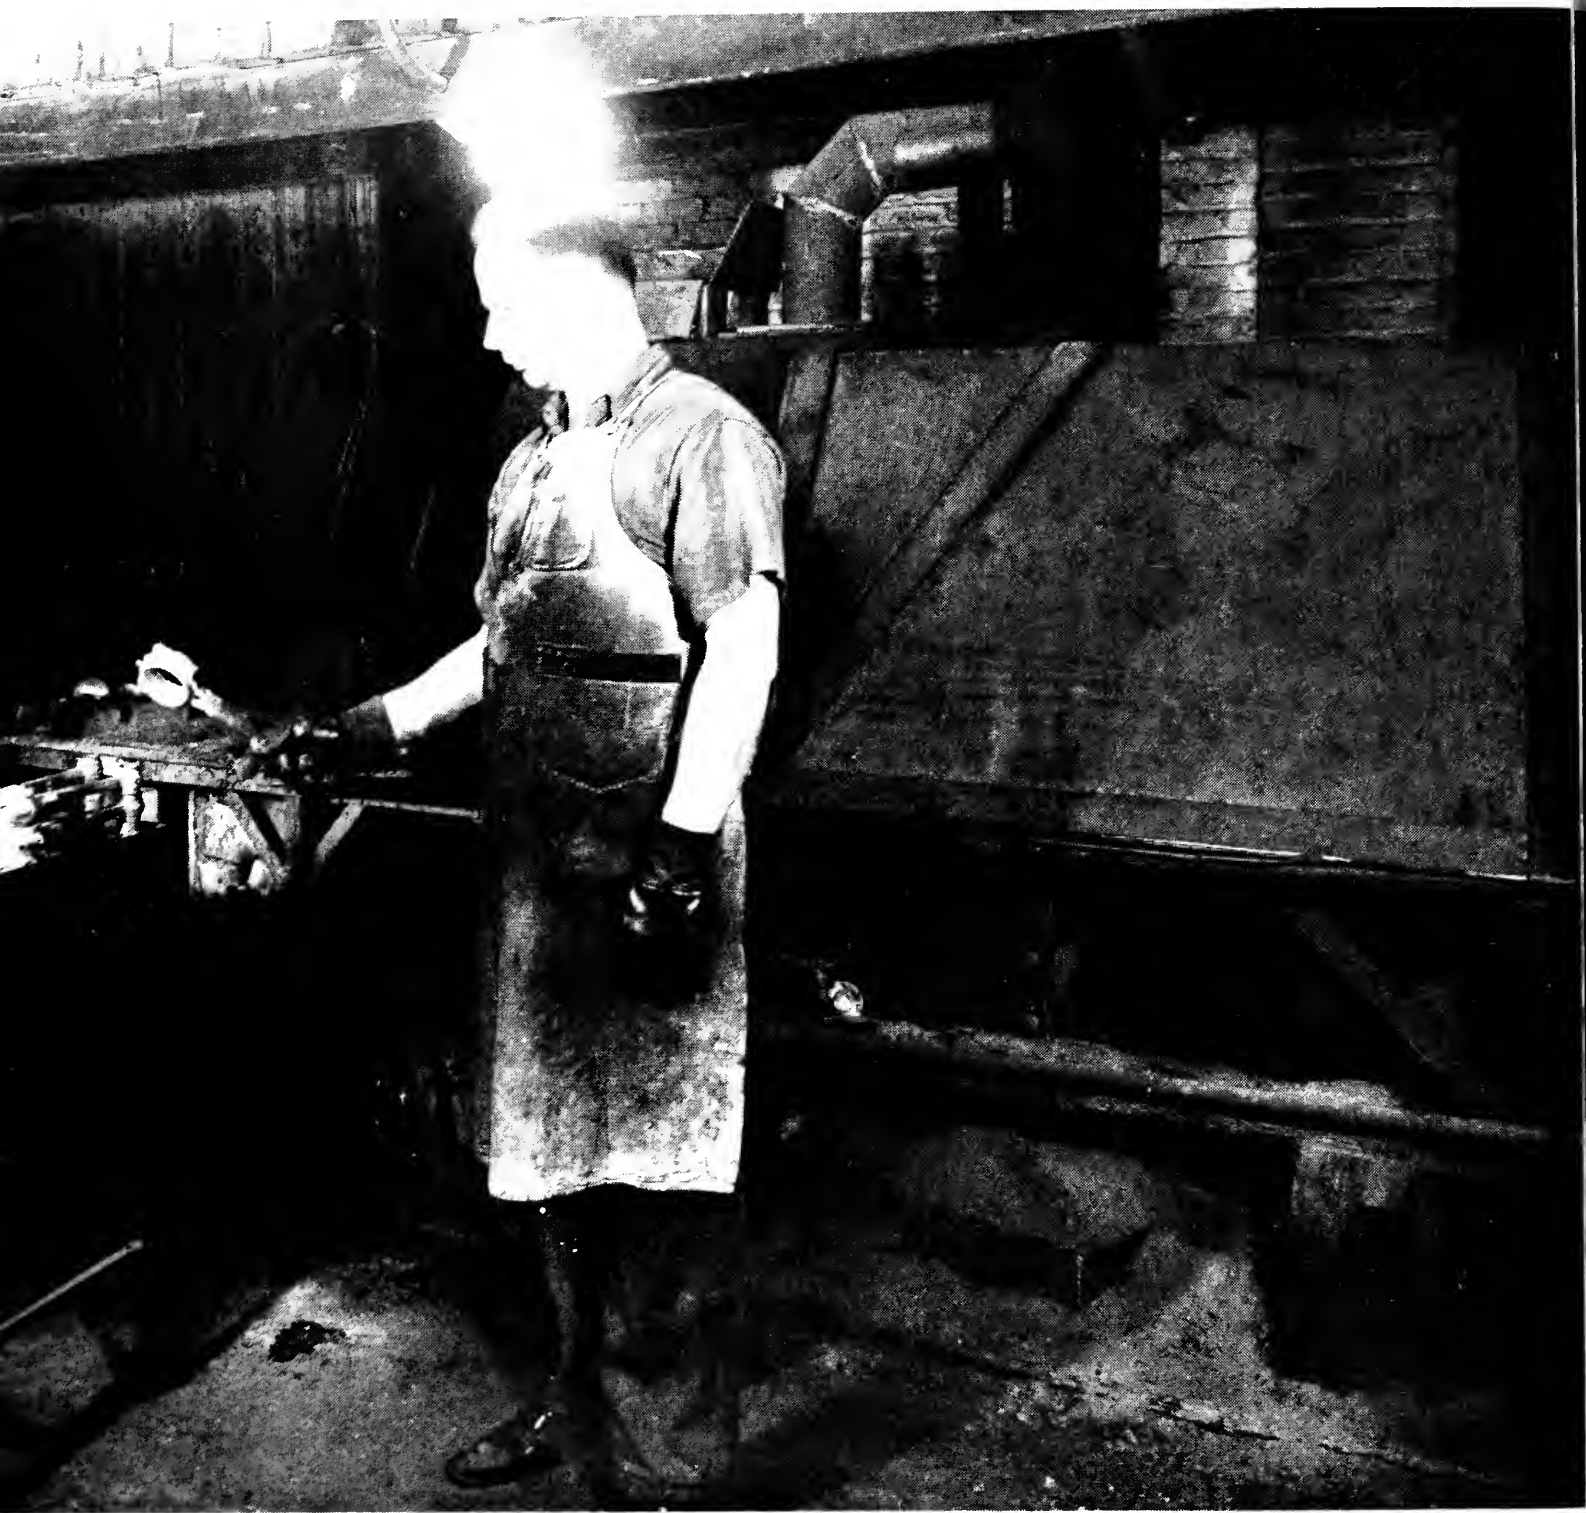
PLAINTIFF'S EXHIBIT No. 8

After any remaining babbitt is chipped off with a chisel, the bearing end of the rod is then dipped into a solution of hydrochloric acid. The acid acts as a cleaning agent. The acid vat is under the wooden cover shown at the right in the above picture. Then the bearing end of the rod is dipped into a molten tin or solder shown on the left in the above picture. This solder or tin acts as a flux or bond when the babbitt is cast against it.

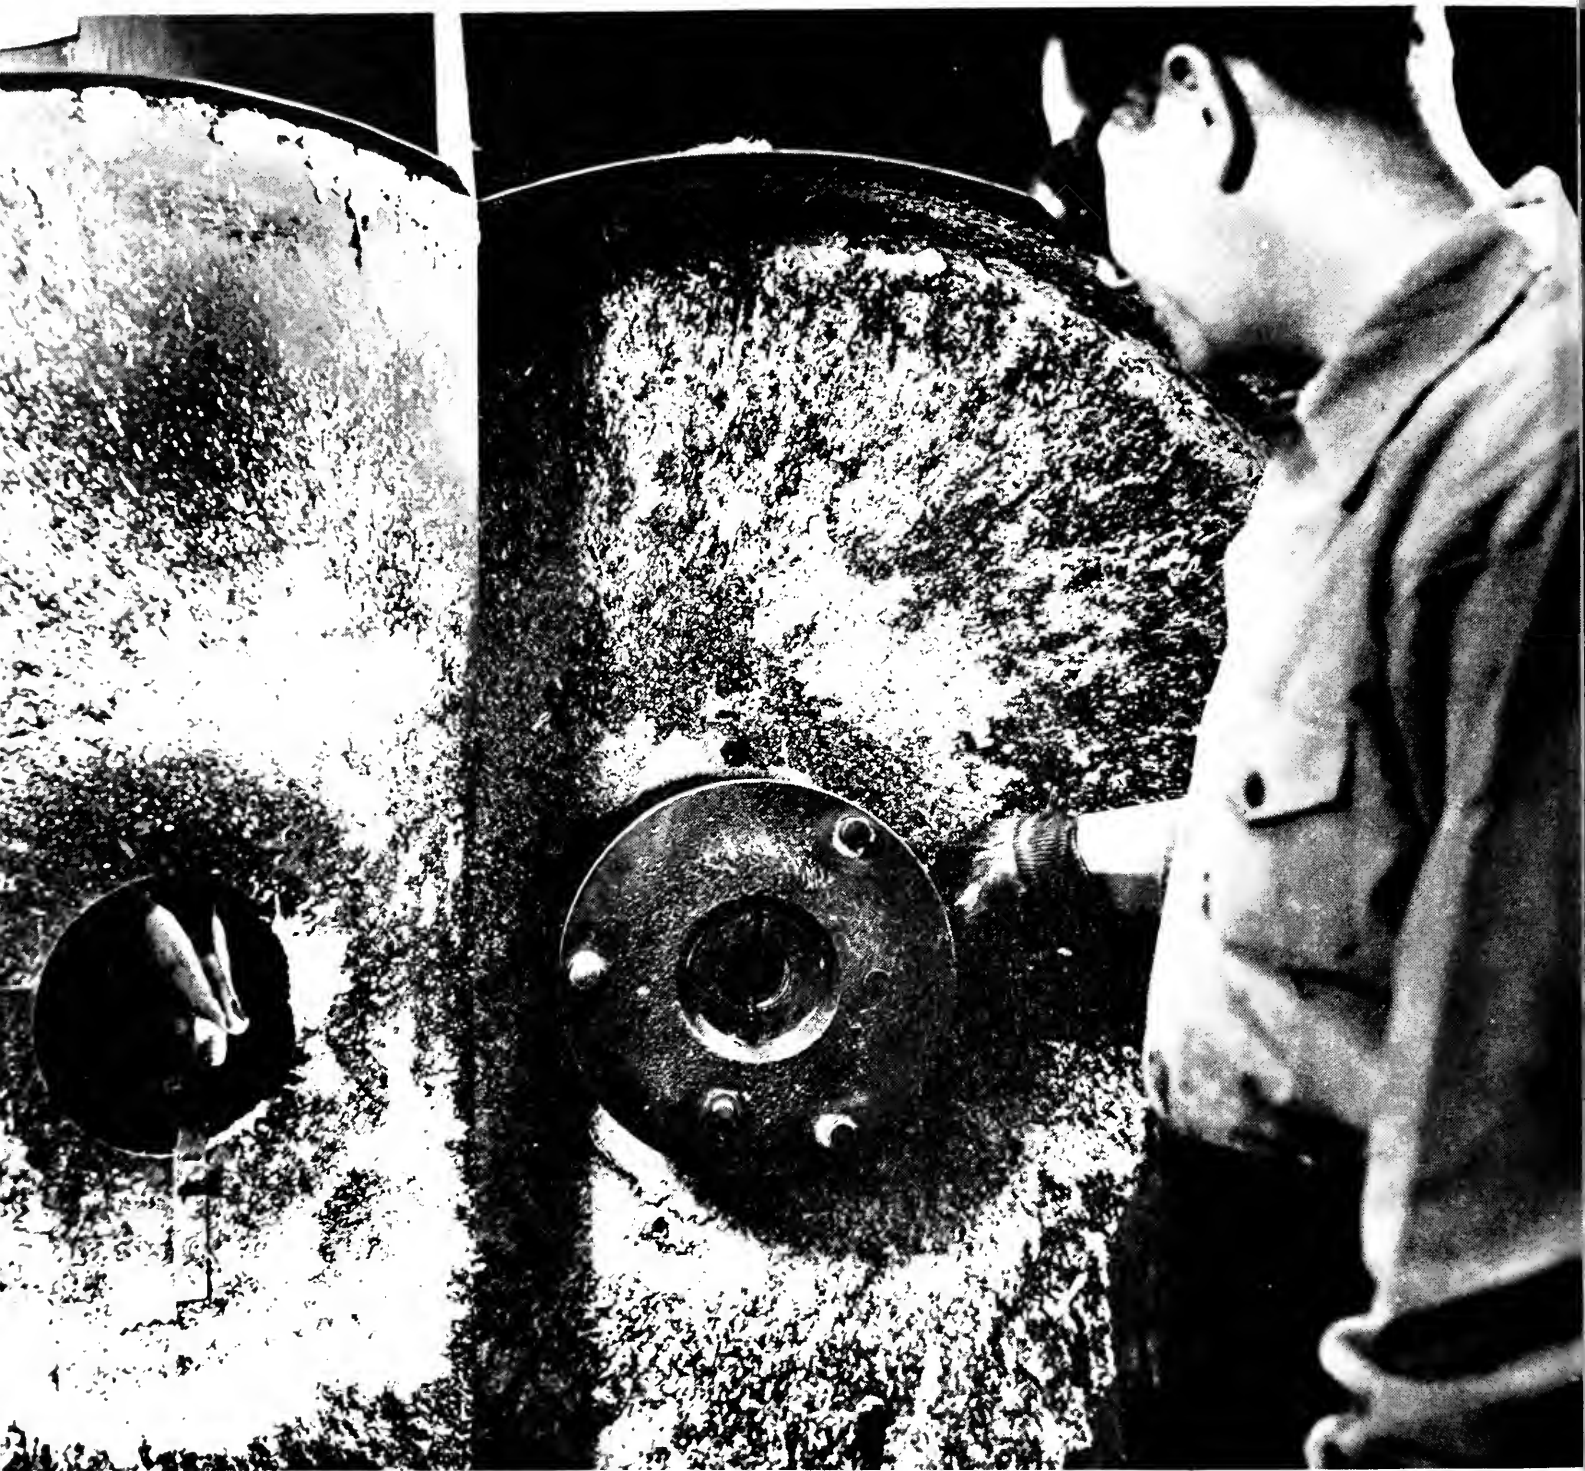
PLAINTIFF'S EXHIBIT No. 11

The rods are then taken to the centrifugal casting machines which were built by Plaintiff corporation for its own use. There are two of these machines because it takes the babbitt about fifteen seconds to cast and thus one operator can run the two machines. Each of these centrifugal casting machines consists of a revolving shaft on which is mounted a mold holder shown above. This mold holder is opened by means of a foot lever and the bearing end of the rod is placed between the molds which cup over each side of the bearing end. The illustration above shows the operator with his right hand covering the shank end of the rod with the bearing end in between the open mold. When the foot lever is released the outer part of the mold seen in the picture snaps back against the bearing end of the rod holding the rod securely so that it makes a perpendicular axis to the shaft on which the mold holder is mounted.

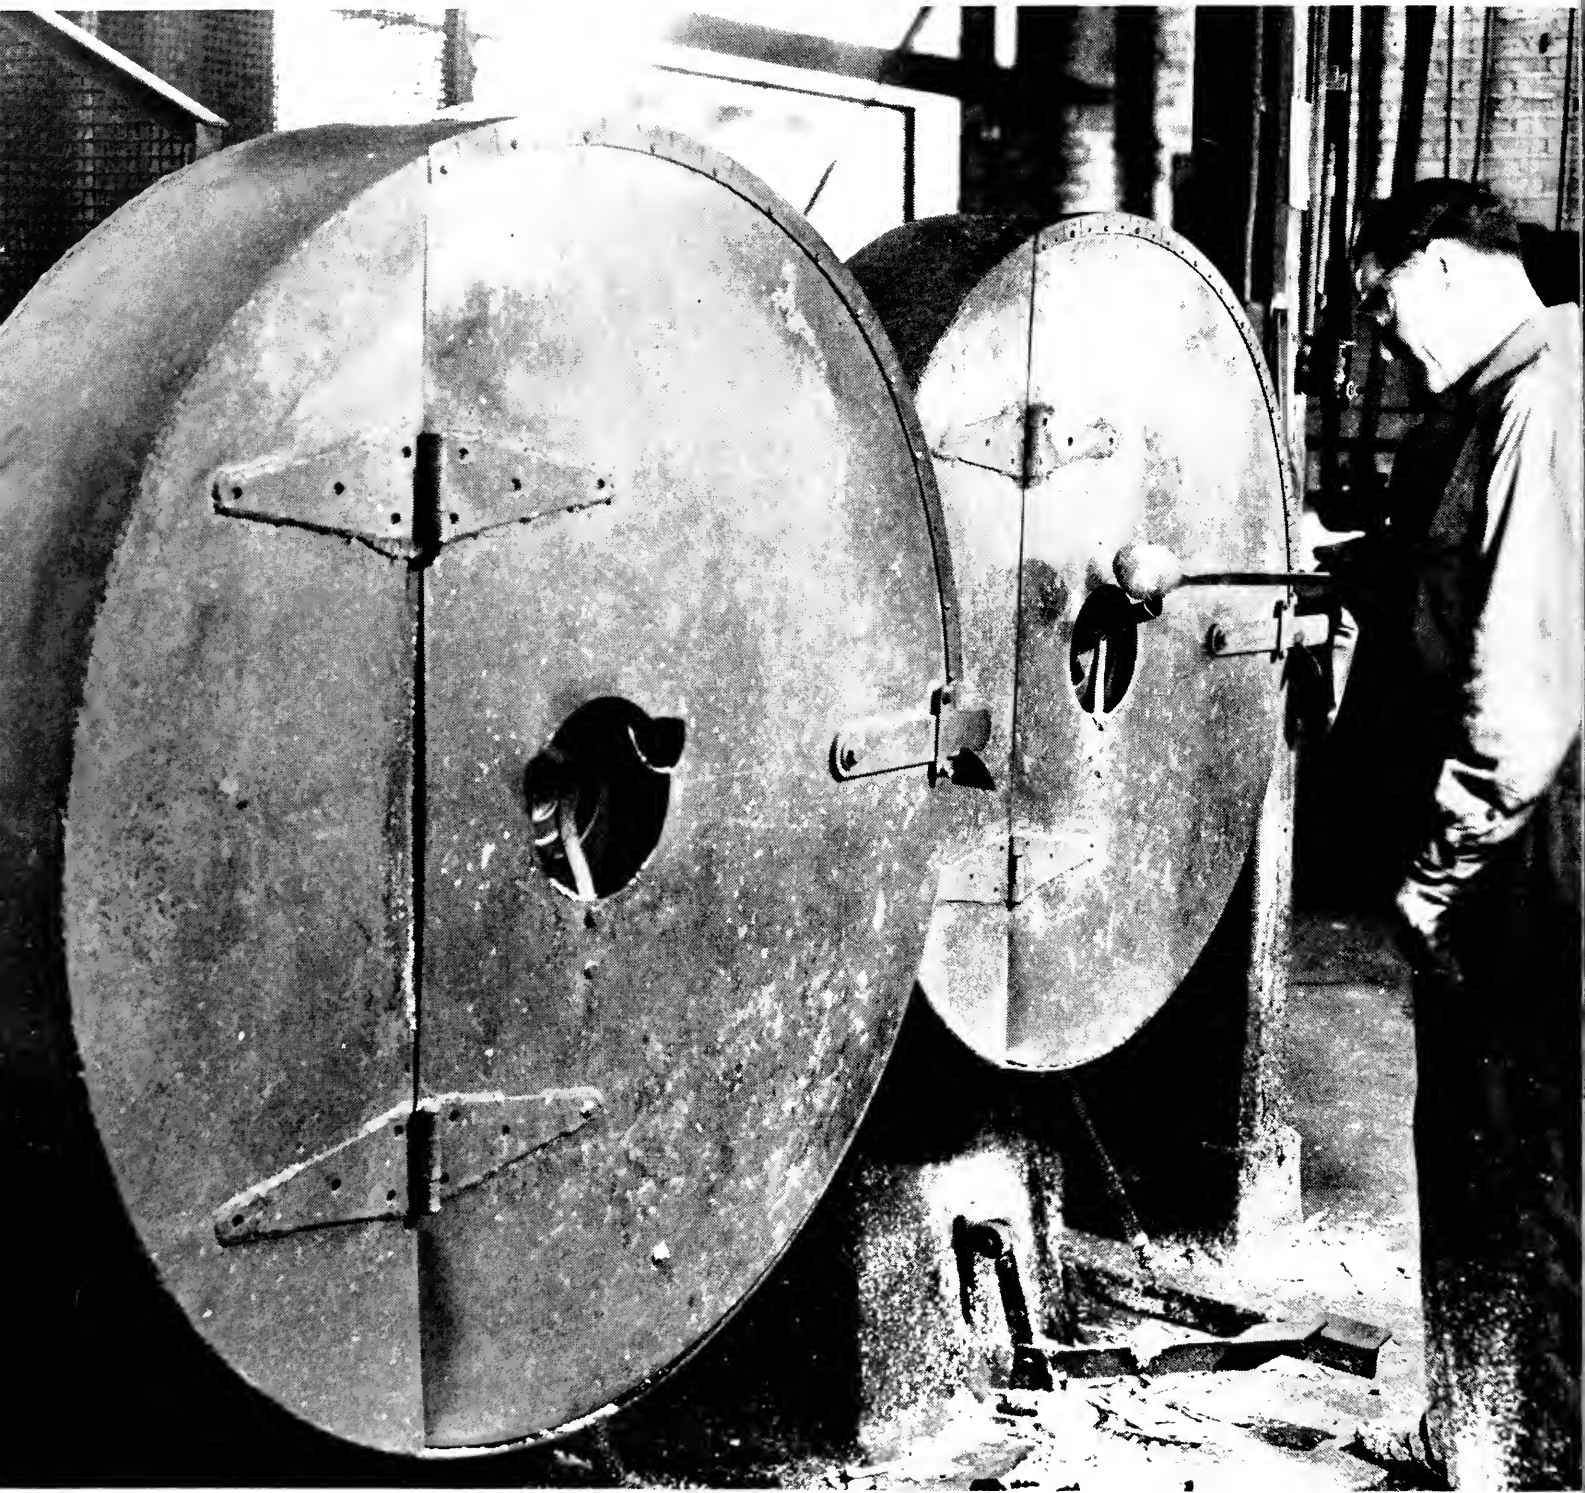
PLAINTIFF'S EXHIBIT No. 12

The mold holder is incased inside a pancake shaped container which is mounted perpendicular to the floor. The center of the door to the container has a hole in it approximately eight inches in diameter. Through this aperture a small trough is affixed as shown above. The small end of the trough leads down into the outer face of the mold which is open. Then when the rod has been set in the mold holder as previously described, the door of the container is closed, and by means of a foot lever the shaft and mold start to revolve spinning the rod with the bearing end as an axis. As the shaft, mold and rod are spun, an operator pours molten babbitt into the trough. The babbitt runs down into the bearing end of the rod and the centrifugal force spreads it evenly over the inside curved surface of the bearing and of the rod.

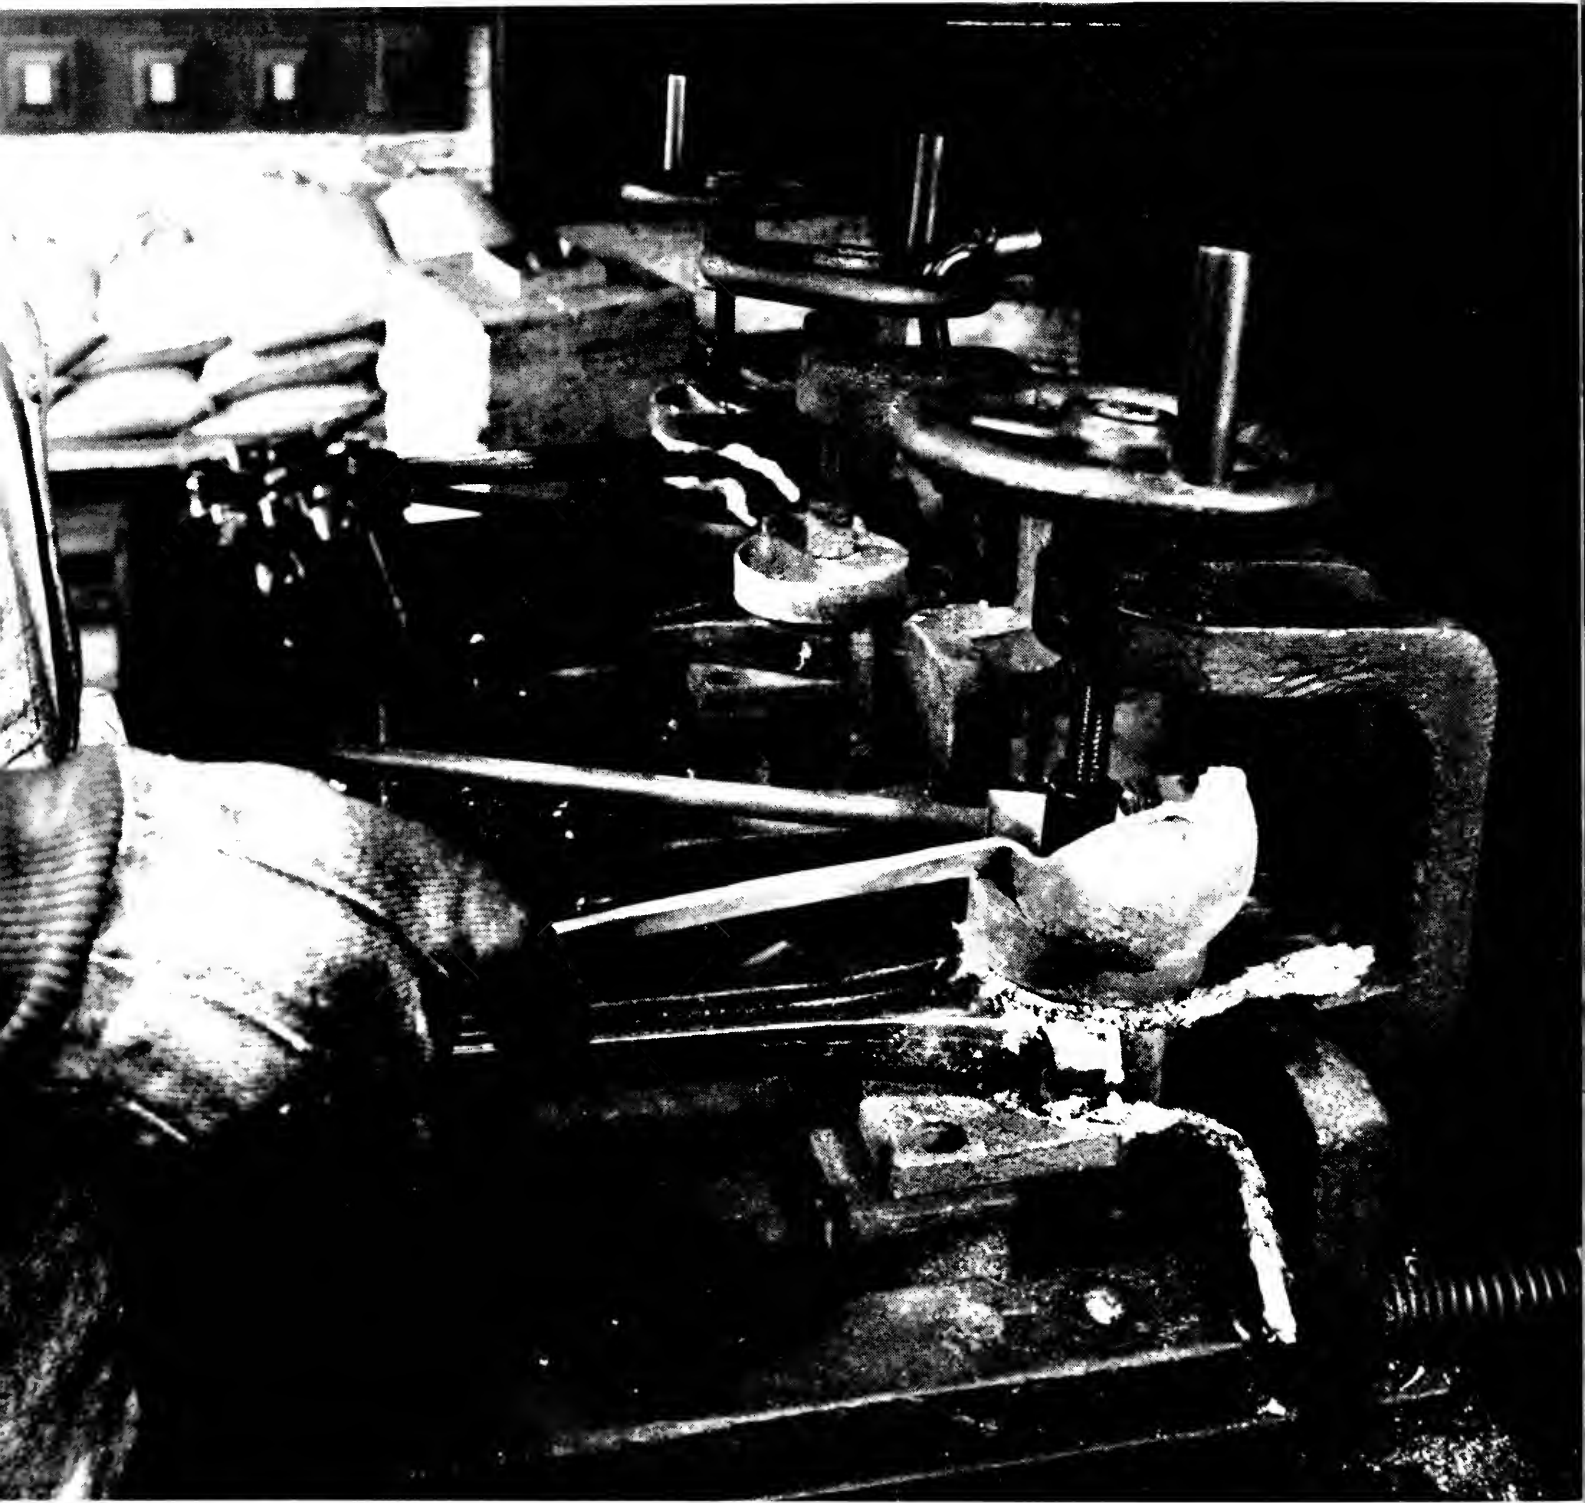
PLAINTIFF'S EXHIBIT No. 13

A certain percentage of the rods must be rebabbitted by hand—about 20%.

In this operation the man who does the hand-casting dips his own rods in the acid and tin for the reason that the place where he works is too far away from the ordinary dipping pit. In the hand-casting the cap is cast separately from the shank by placing either the cap or the shank flat between two molds which cup on each side of either the shank or cap. Between the rod and the mold there is wedged an asbestos wicking to prevent leaks; then the operator pours the molten babbitt through a hole in the top of the mold and it drops through to the inside of either the cap or the shank, whichever part is being babbitted. The surplus babbitt is then chipped off by an operator.

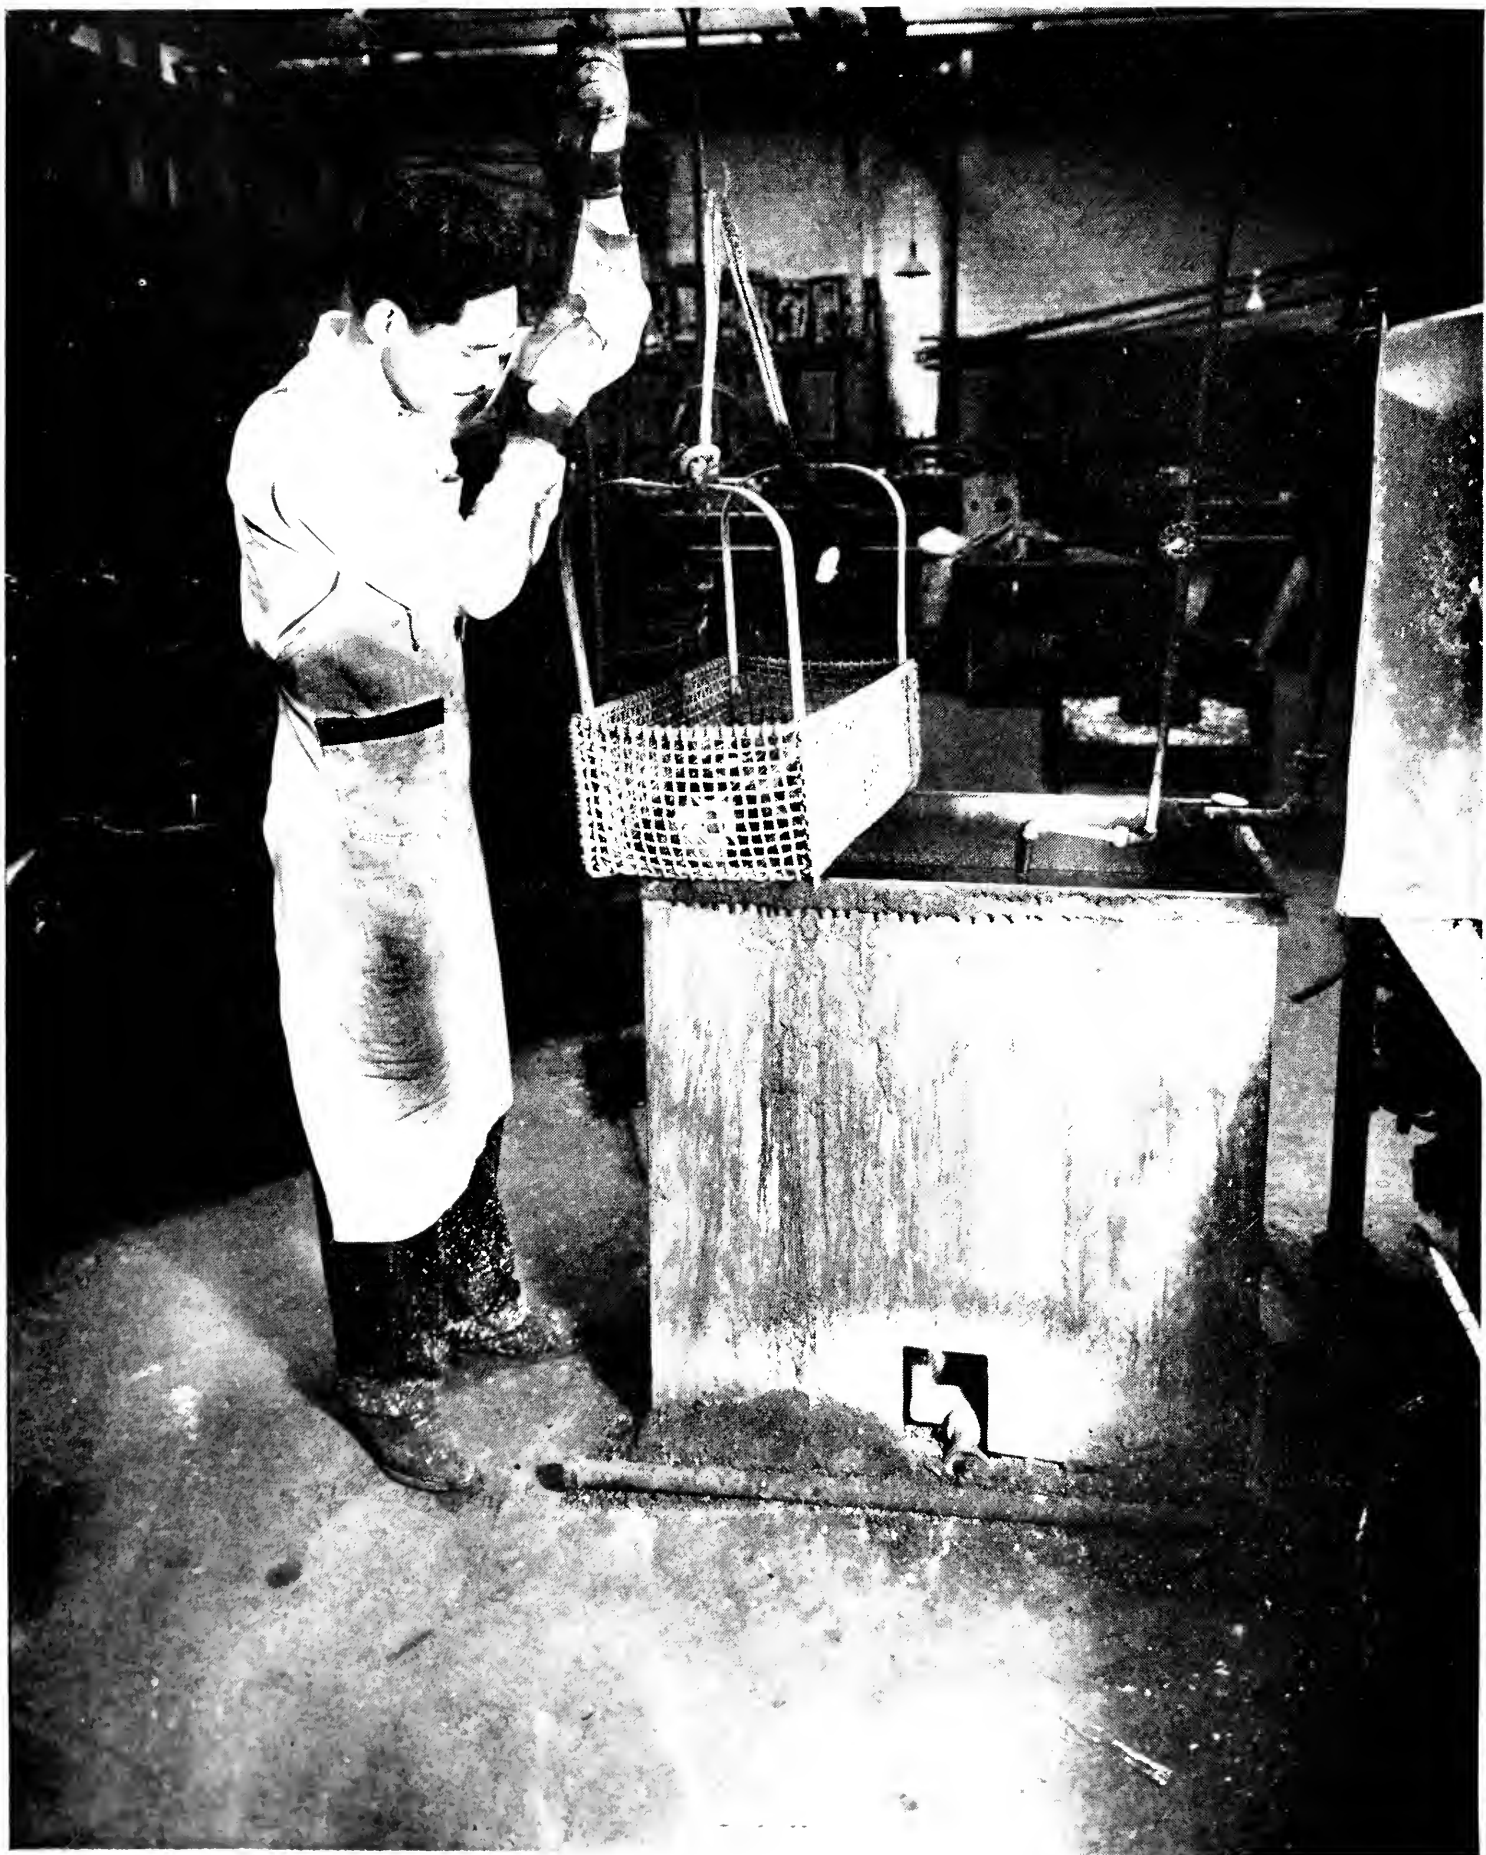
PLAINTIFF'S EXHIBIT No. 14

Then the rods are dipped into an oakite tank as shown above for cleaning.

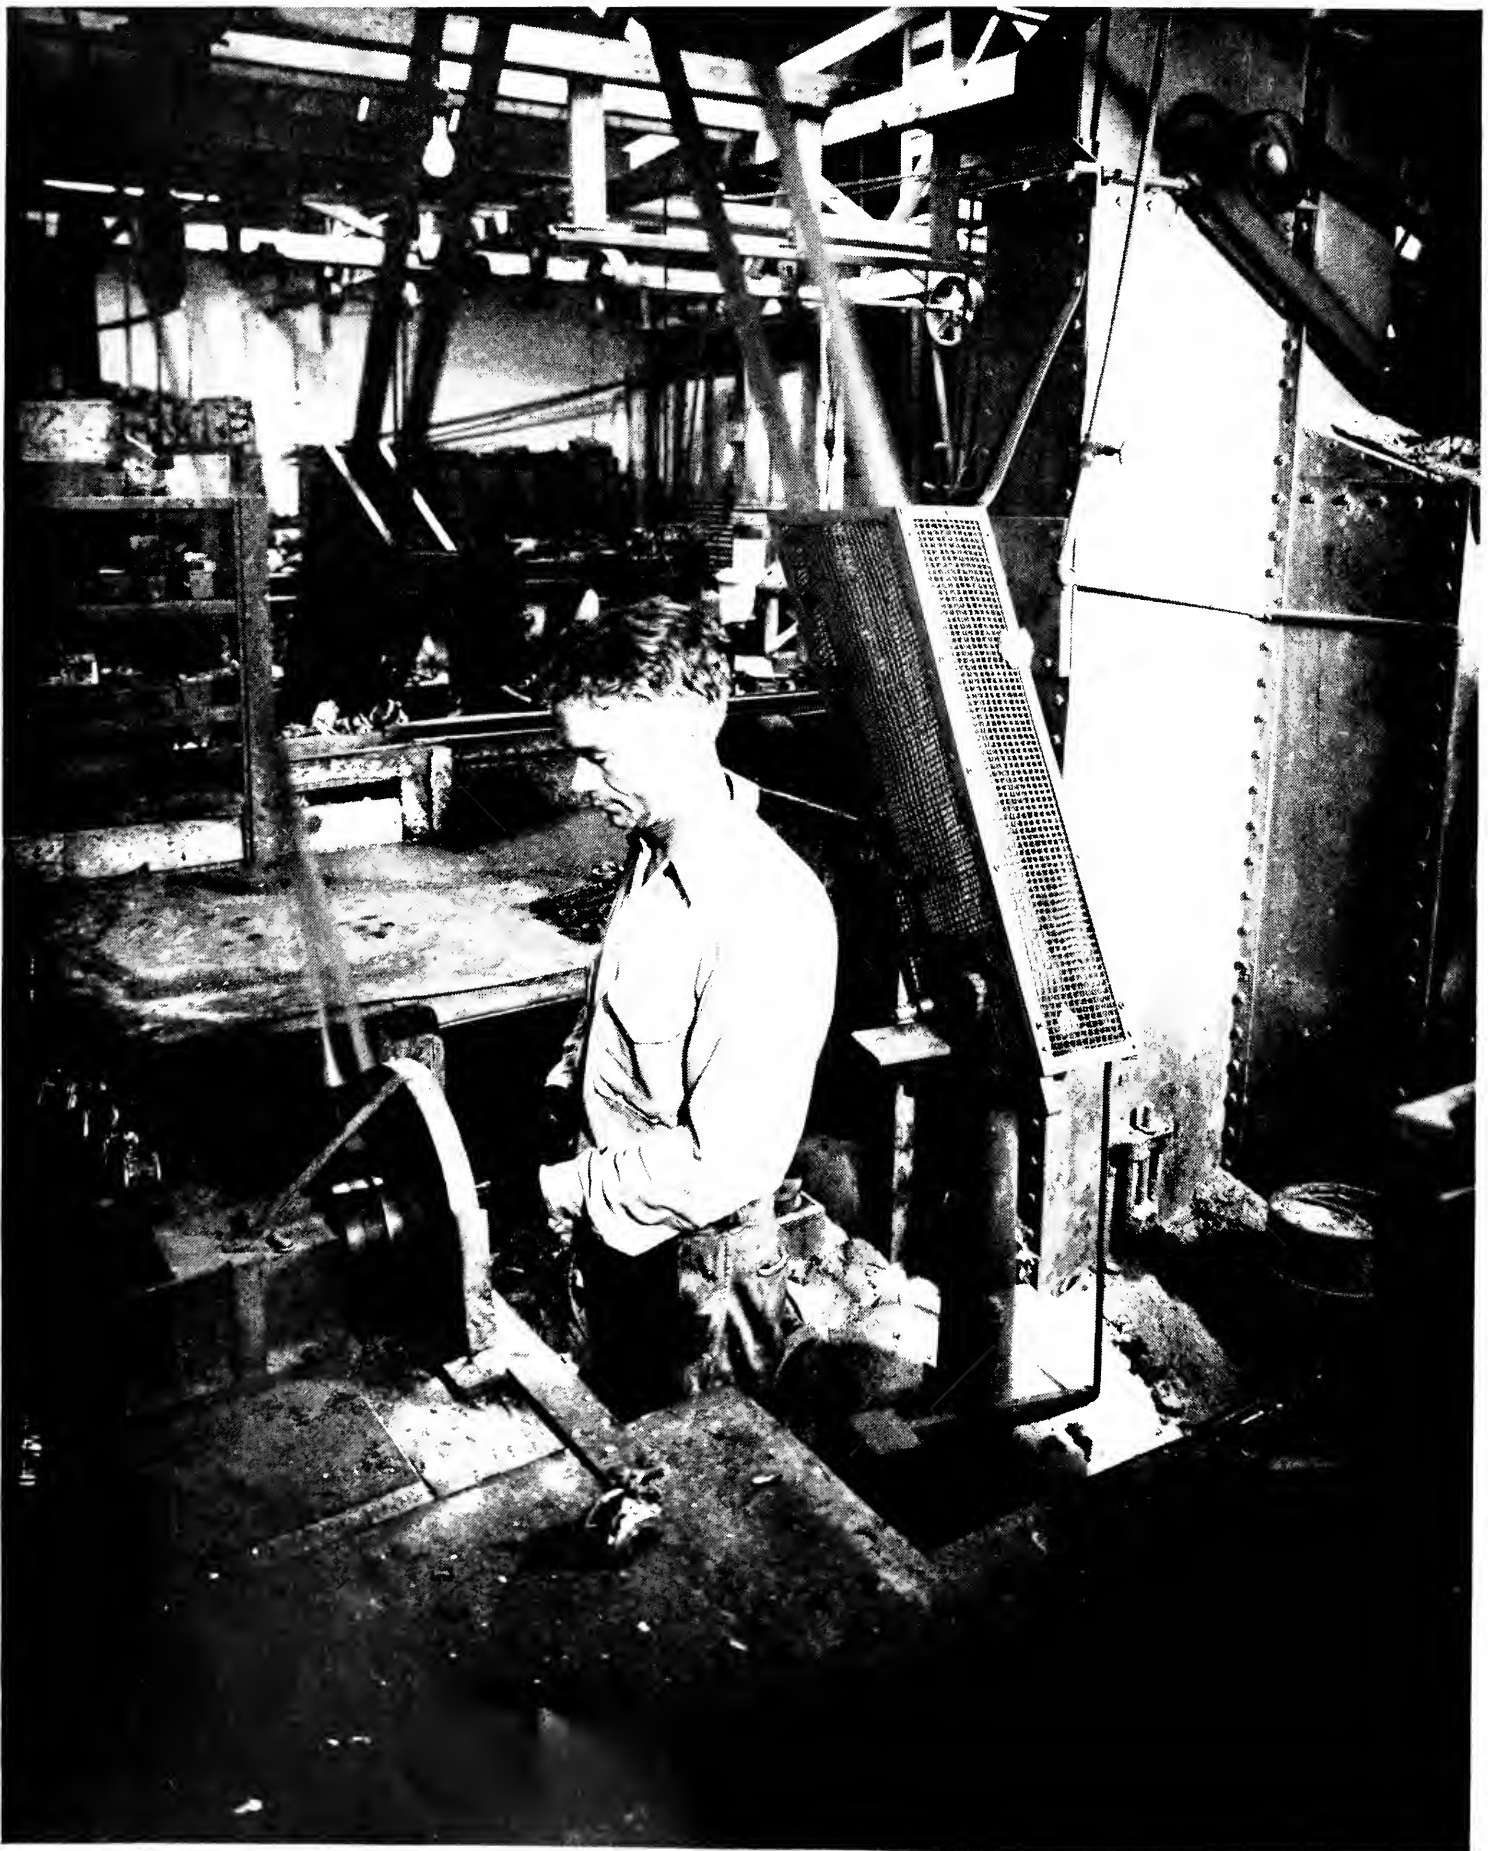
PLAINTIFF'S EXHIBIT No. 16

However, before the cap is fastened to the bearing end of the rod any ragged edges of babbitt which may have adhered where the shims separated the cap from the bearing end of the rod are removed by holding the open face of the cap or the open face of the bearing end of the rod against the revolving sandpaper disc as shown above.
